IT/AV Re-Imagined by:

Constrology
at the intersection of construction and technology

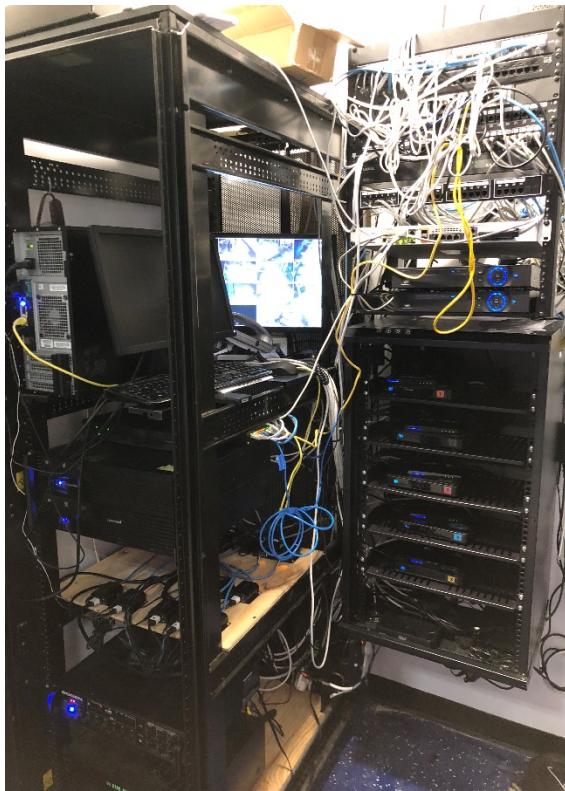
BEFORE – plywood racks holding cheap HDMI over CAT5 video and audio systems, this 40” deep rack nearly stretched from one side of the small room to the other. Wasted wall rack for 5 satellite receivers and HDMI splitters.
